OPC PROP 1 - 2016
Connecting a Tributary in the Salt River Coastal Watershed
Humboldt County Resource Conservation District

Photos

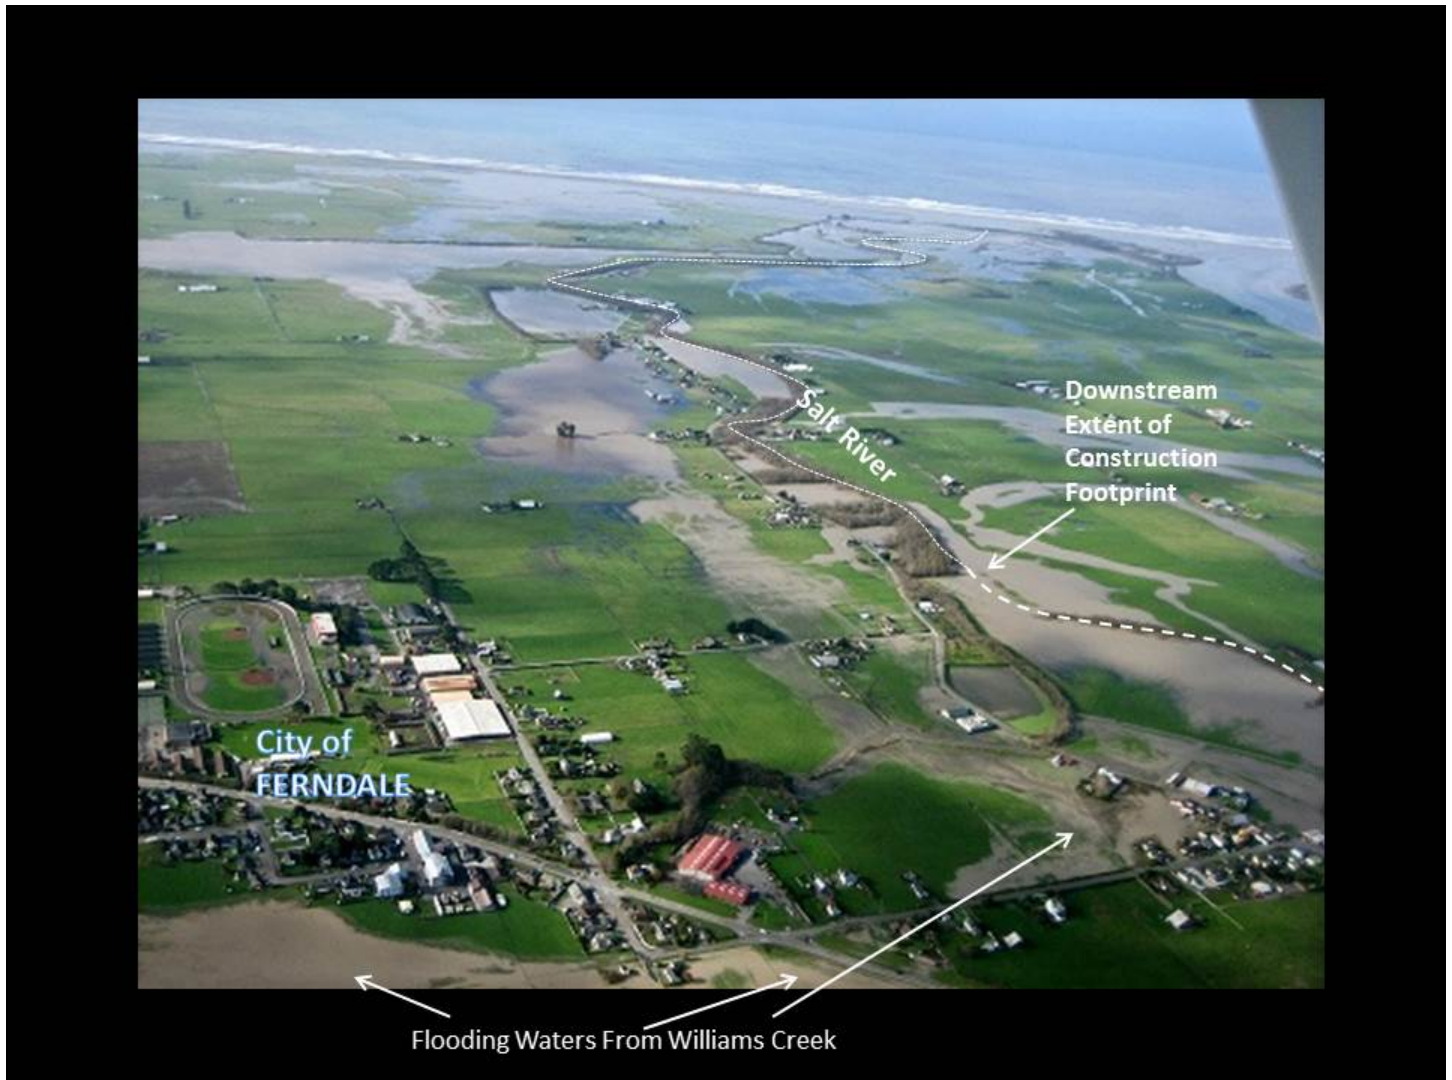
PHOTO – Flooding in winter 2012/2013. Shows downstream extent of the Construction Footprint and flooding waters contributed by Williams Creek due to the absence of a Salt River Channel.

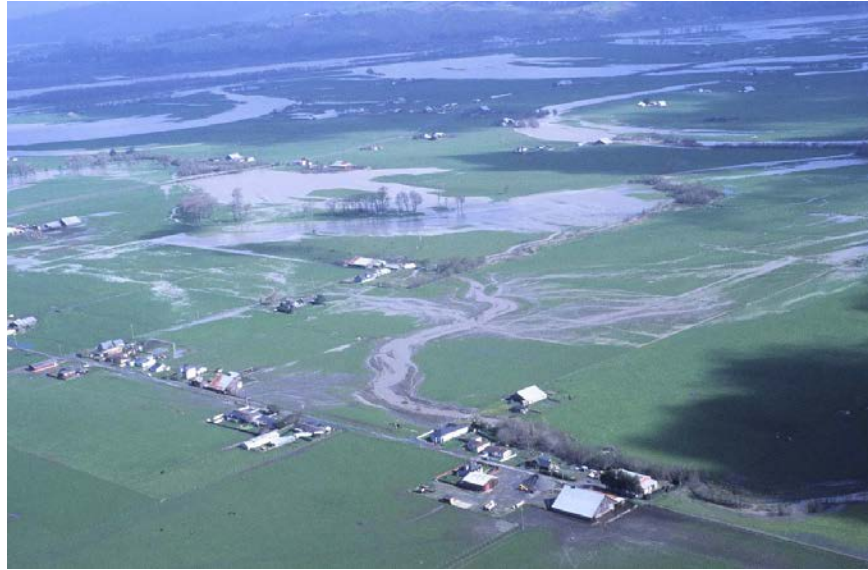
PHOTO - Flooding at lower Williams Creek. Salt River historic channel is in mid-ground with scattered trees along channel. A sediment plug in this location blocks the flow of 42% of the watershed, causing chronic flooding and ponding and reducing sediment transport capacity.

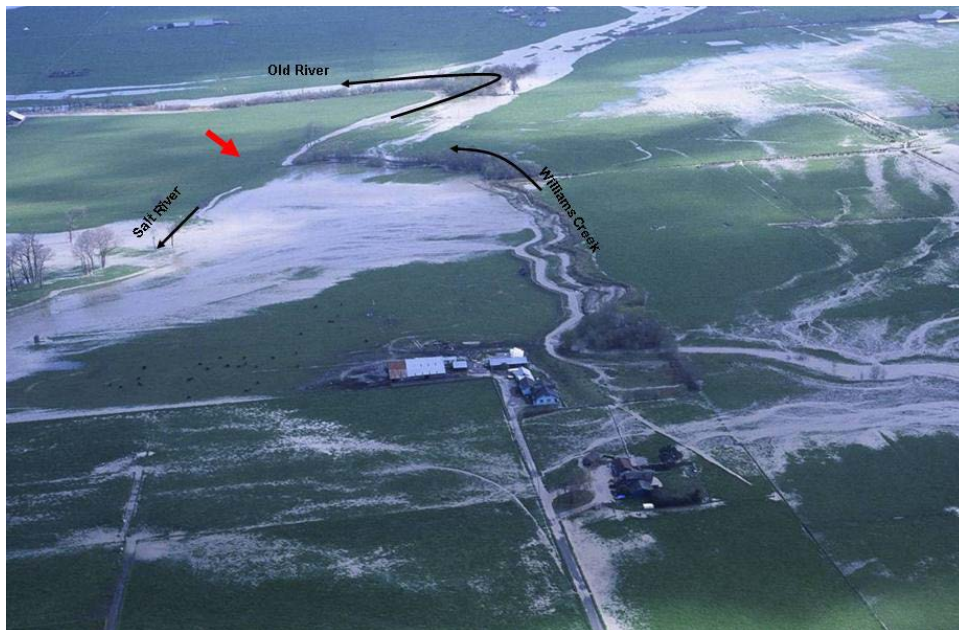
PHOTO - Photo indicates where the Salt River Channel should be. Red arrow indicates the sediment plug in the Salt River, where Williams Creek's flow is diverted upstream to a remnant slough "Old River".

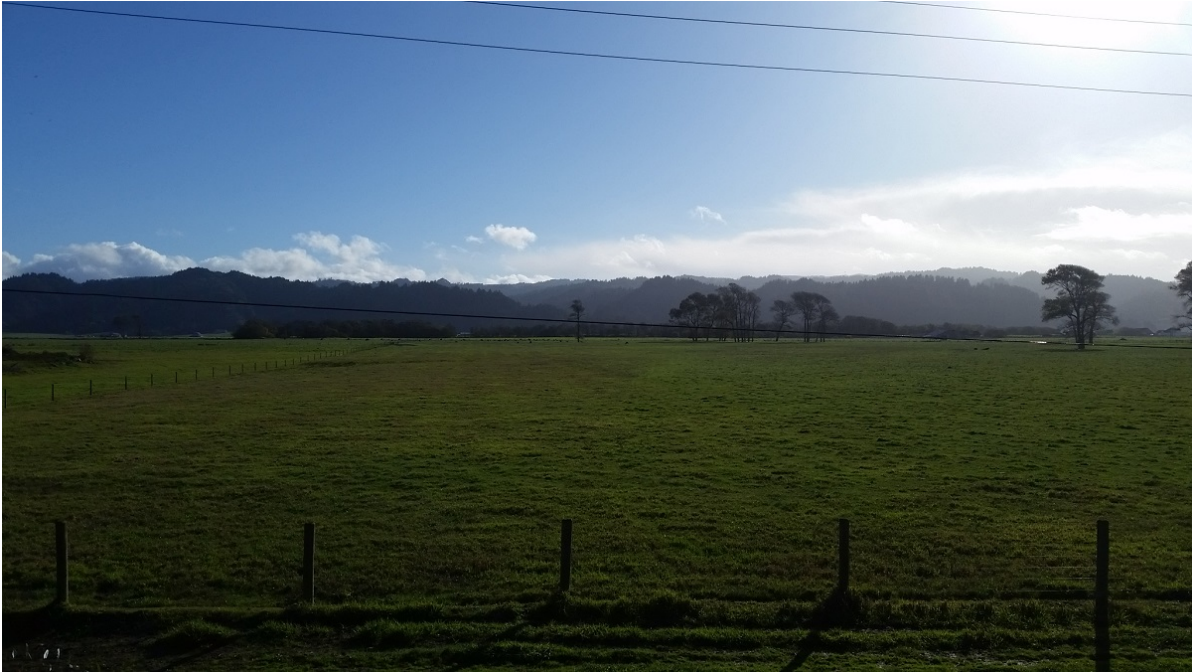
PHOTO – Looking out over the “Salt River” up towards the Williams Creek watershed from a highway overpass. The Salt River channel has completely filled in with sediment and is currently utilized as pasture.
Date: 9 November 2015

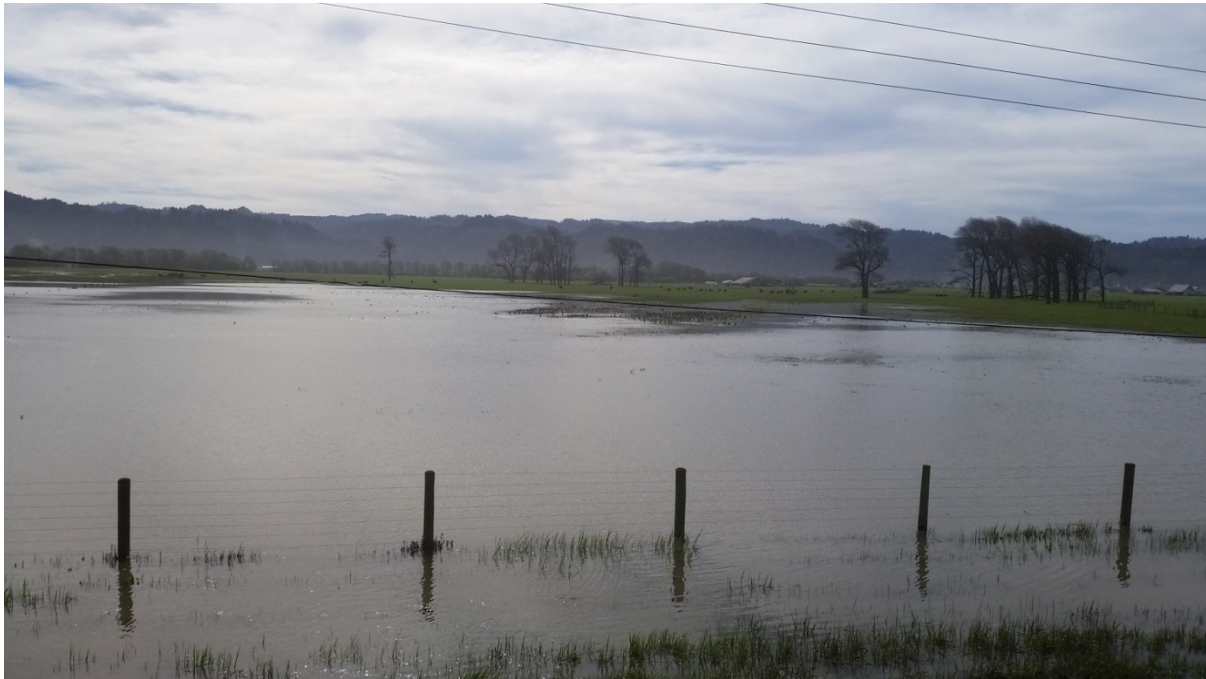
PHOTO – Same location above with winter rain events causing ponding due to absence of a Salt River channel. Ponding will likely persist until May/June. Date: 9 February 2015
