**Tolowa Dee-ni' Nation**  
**LID AND STORMWATER OUTFALL IMPROVEMENT PROJECT**  
**PHOTOS**

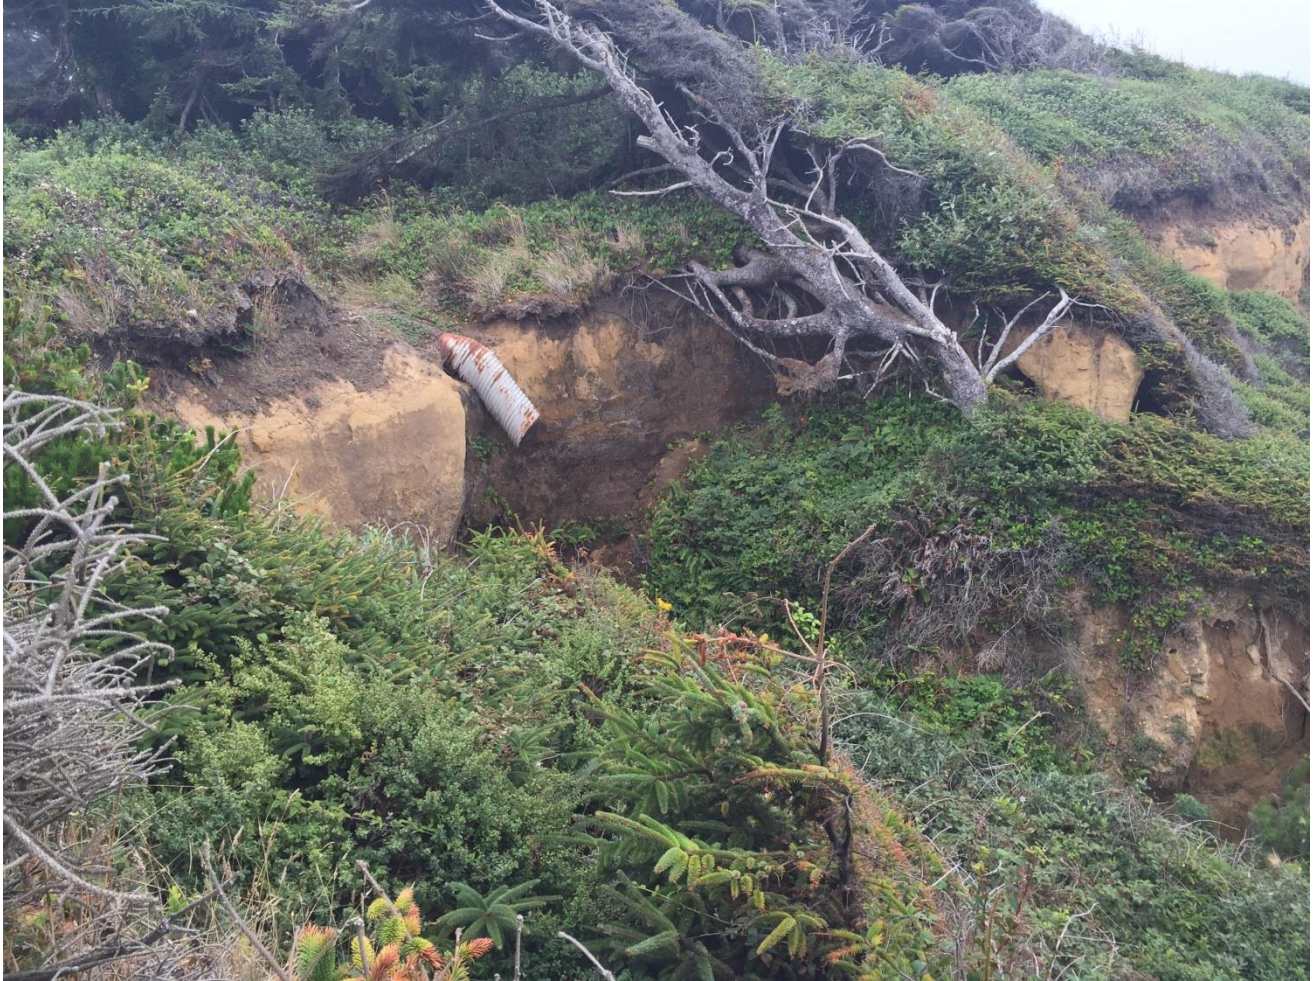
**Photo 1: View of existing stormwater outfall adjacent to Pyramid Point State Marine Conservation Area. Undercutting of the Bluff is visible.**

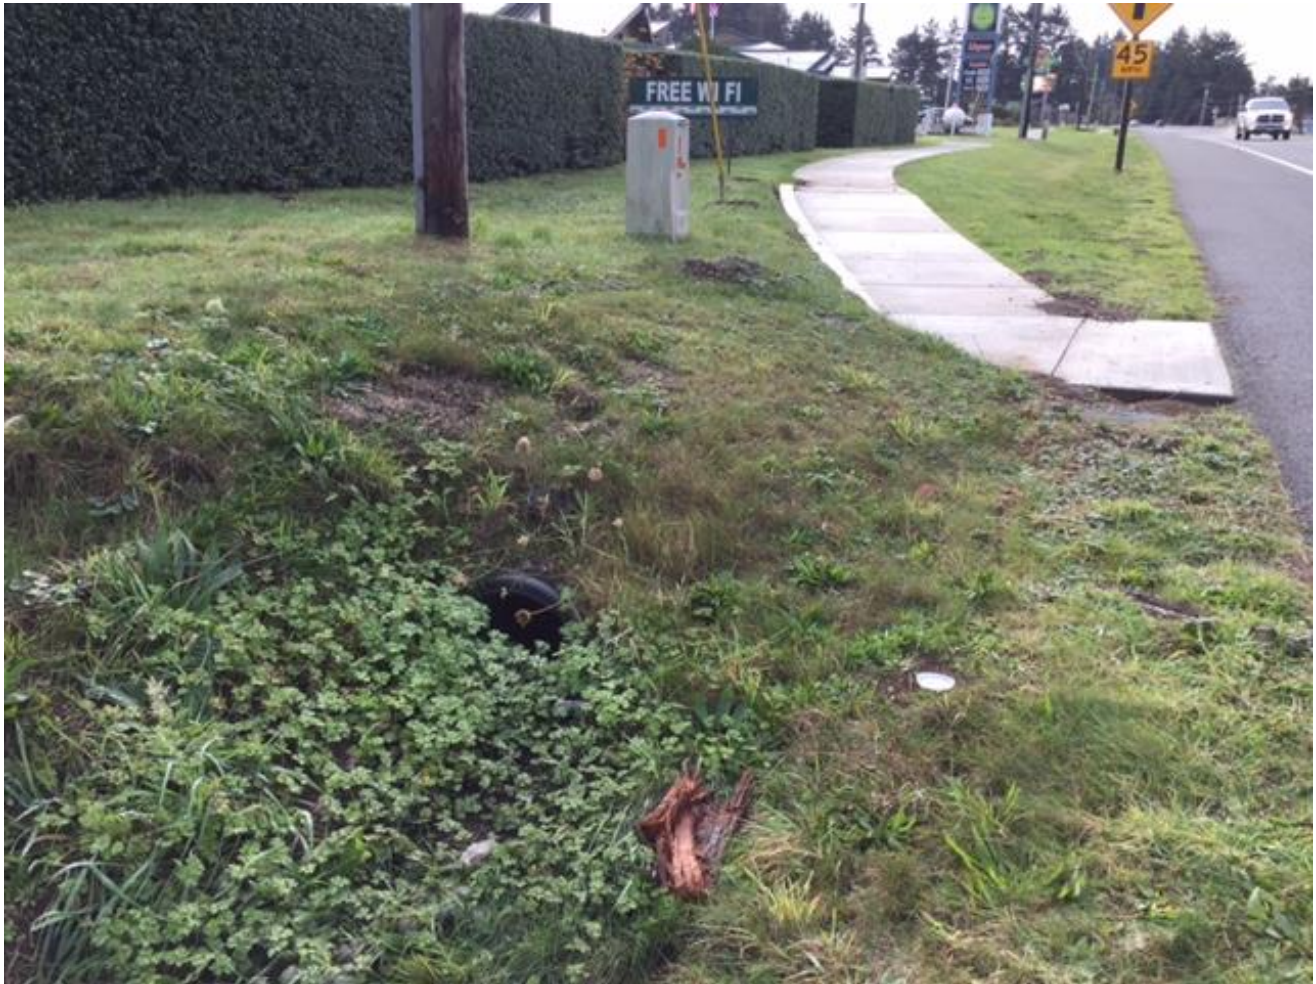
**Photo 2: Existing outlet of Fuel Mart storm drain system along US101, proposed location for new bioswale**

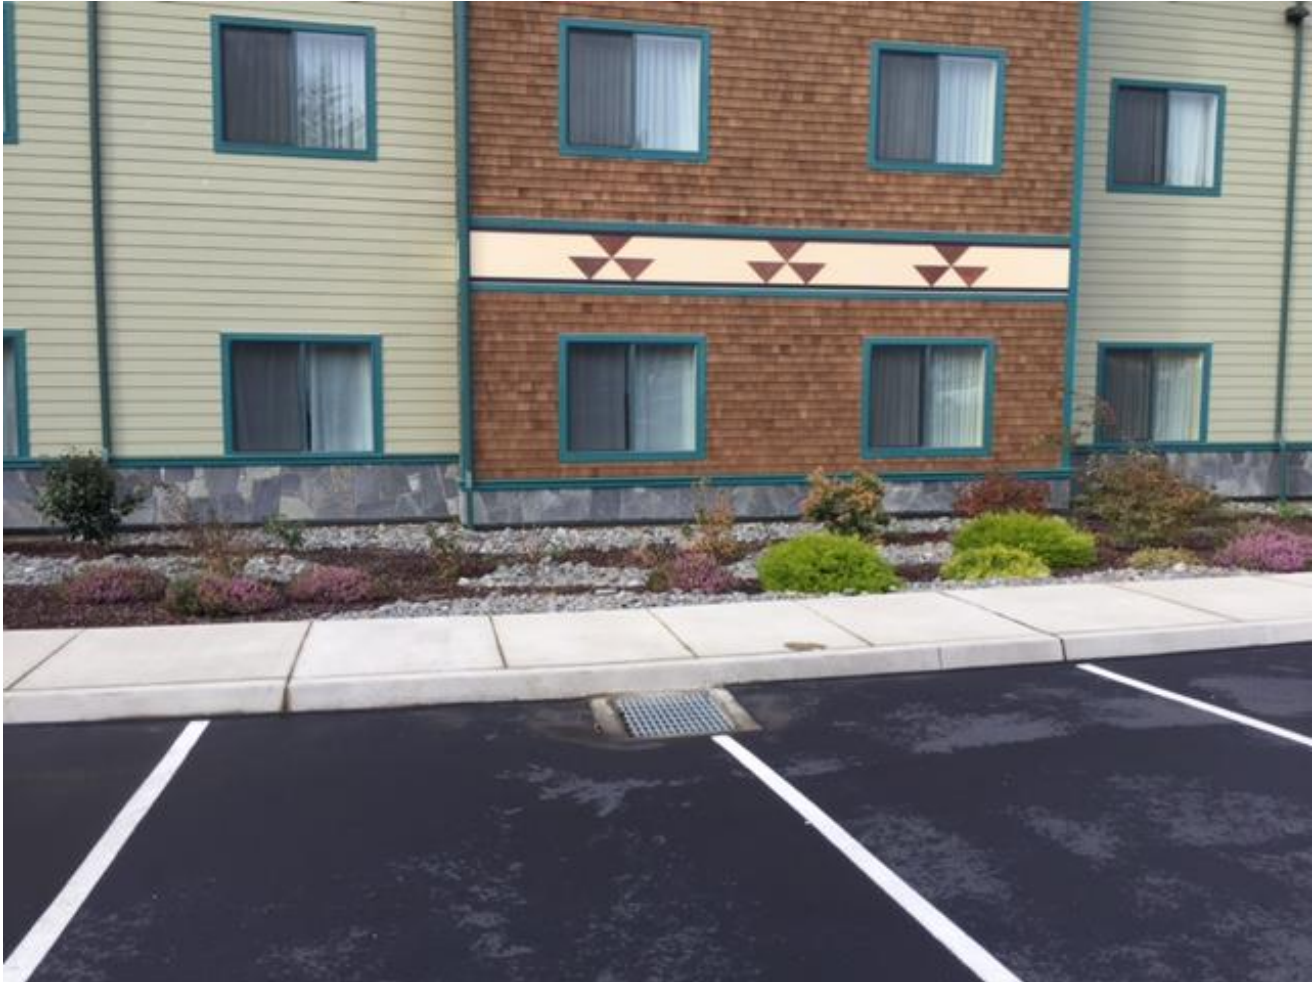
**Photo 3: One proposed located for installation of a rain garden. Stormwater will be routed through the rain garden prior to discharge to the storm drain.**

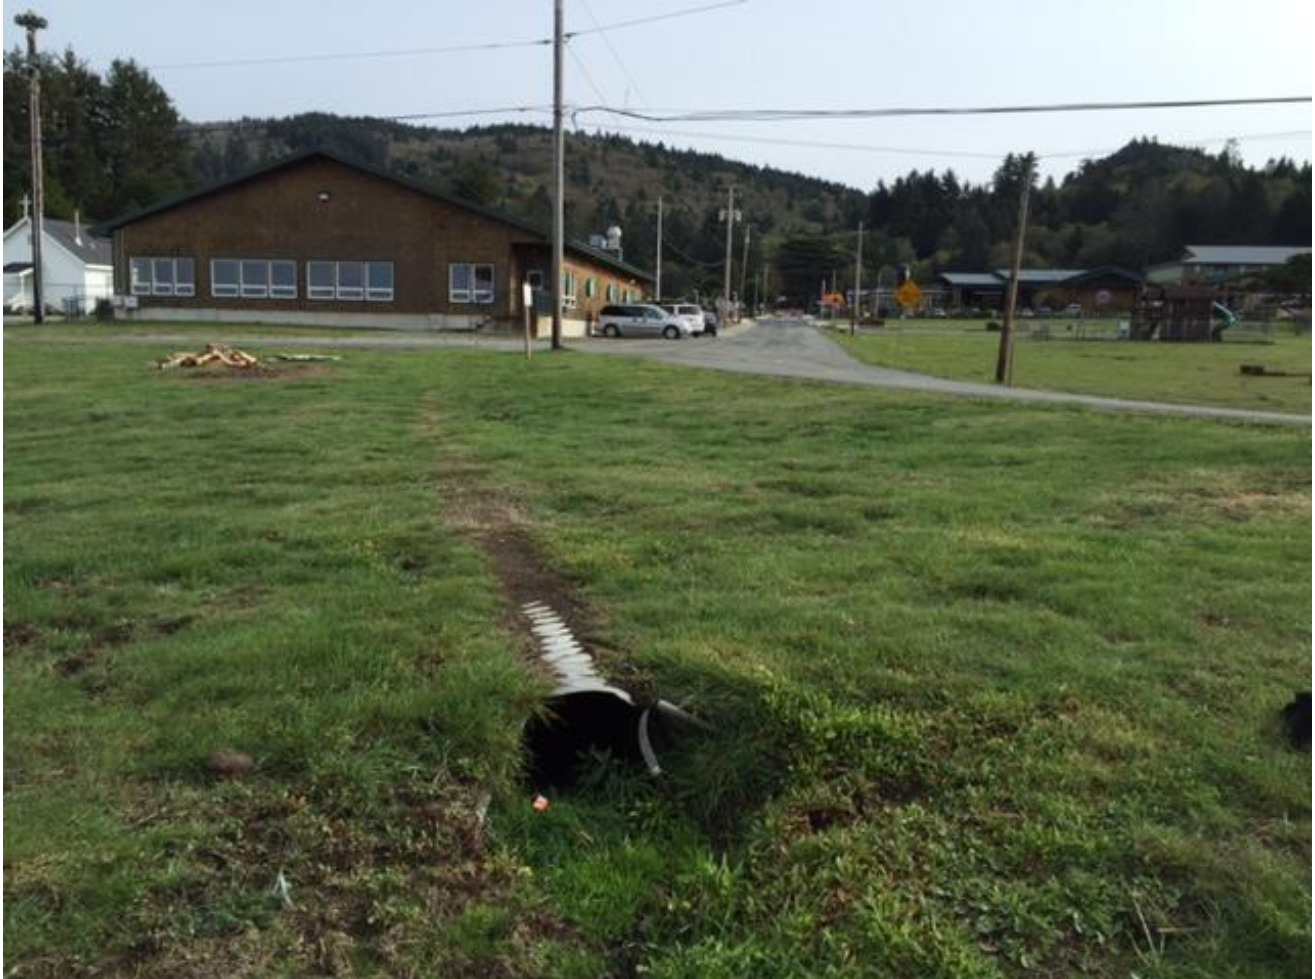
**Photo 4: Existing outlet for Community Center which drains over the bluff west of North Indian Road. Project proposes to reroute stormwater to a new bioswale and connect to a new storm drain and downdrain.**

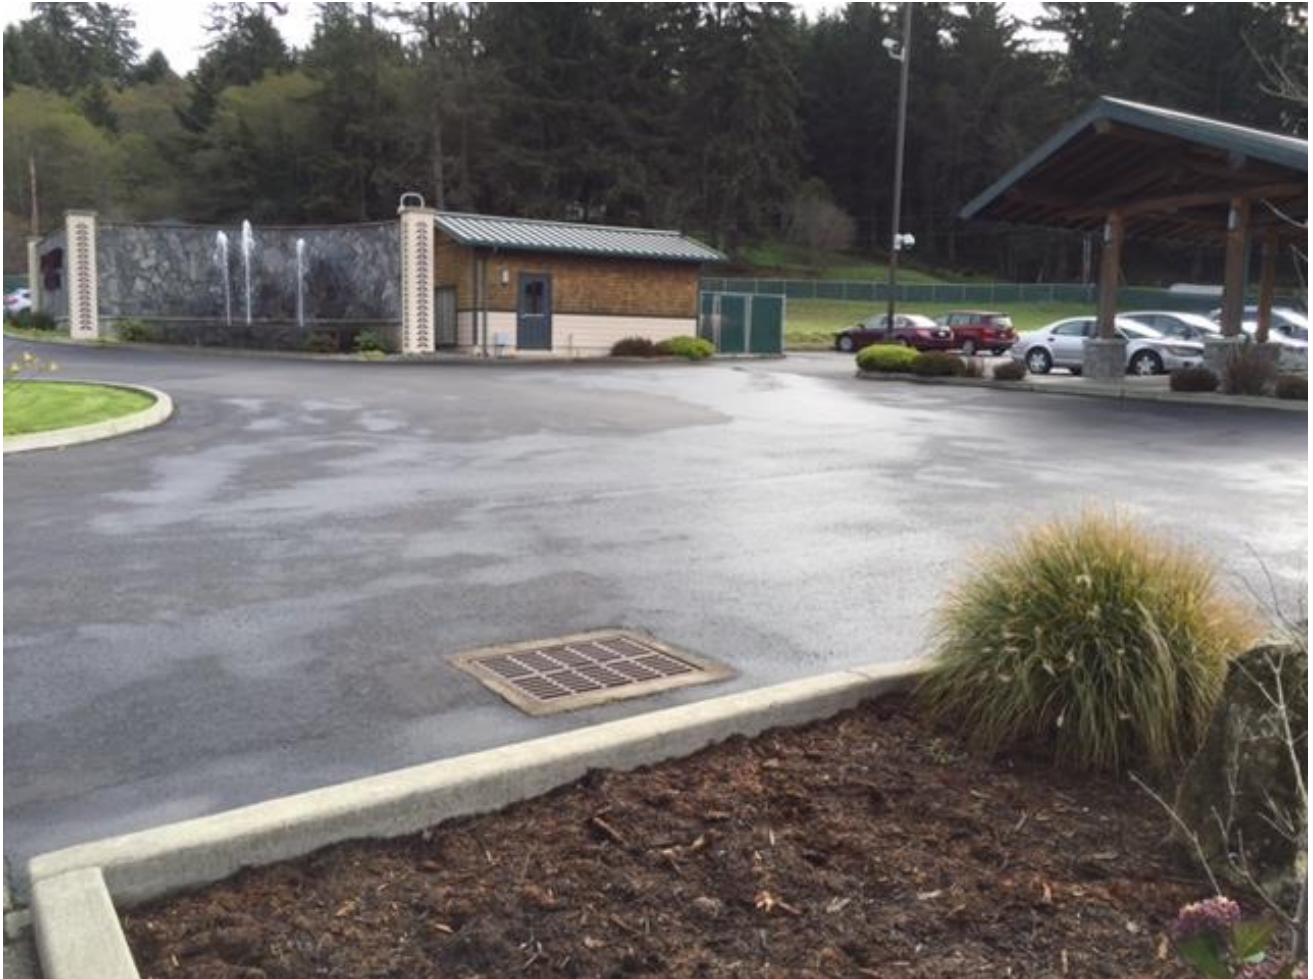
**Photo 5: One proposed located for installation of a rain garden. Stormwater will be routed through the rain garden prior to discharge to the storm drain.**
