EXHIBIT B: Site Images

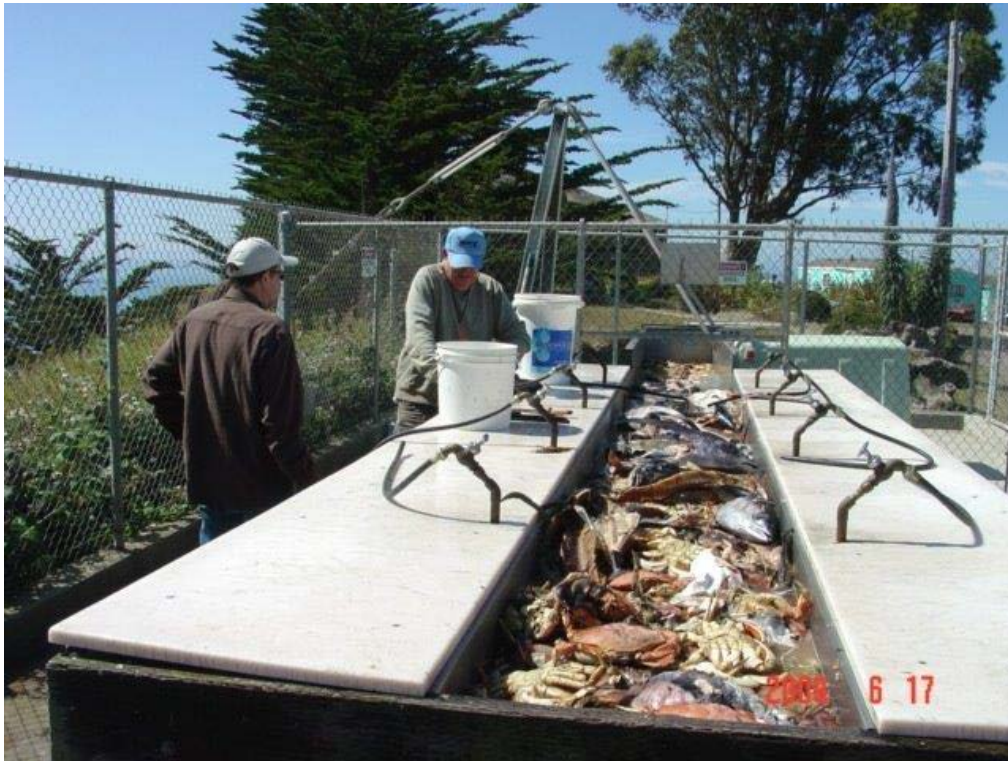
Figure 3. Fishermen using fish cleaning table at existing facility, Shelter Cove, Humboldt County, California.

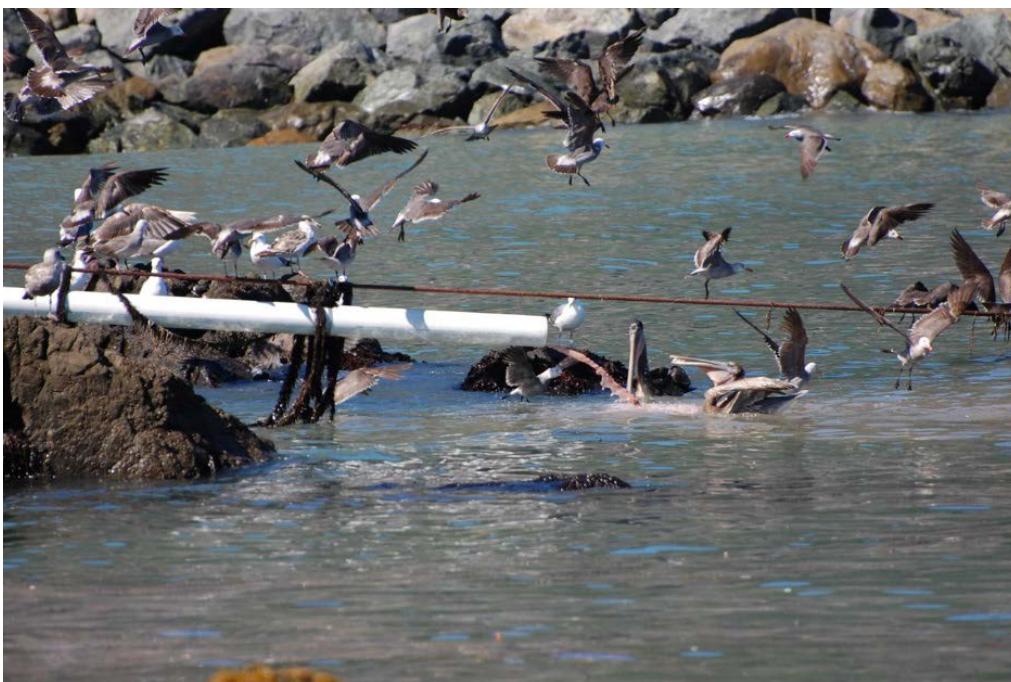
Figure 4. Photograph of seabirds congregating near fish waste disposal pipe at Shelter Cove, Humboldt County, California.

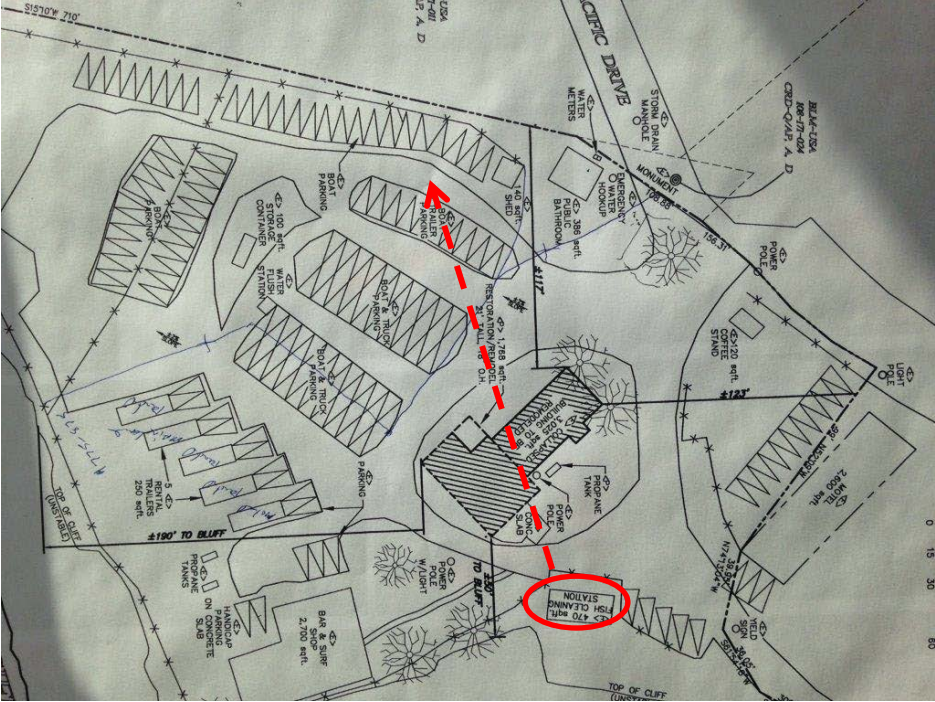
Figure 5. Current plot plan of Shelter Cove Boat Launch Facility. Proposed project includes eliminating current direct discharge from pipe into ASBS by relocating fish cleaning station away from cliff and repurposing fish waste as commercial crab bait and organic fertilizer. Wash water will be plumbed into sewer treatment system.

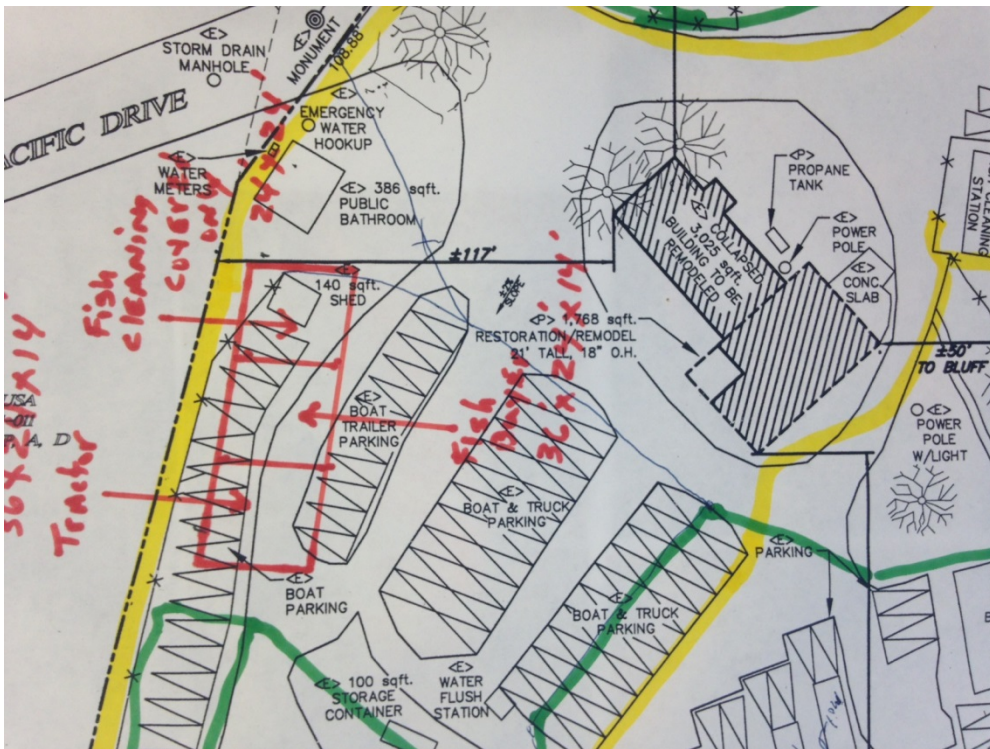
Figure 6. Hand drawn details of proposed Shelter Cove Remediation Project
